REPORT 1133

MECHANISM OF START AND DEVELOPMENT OF AIRCRAFT CRASH FIRES 1

By I. IBVING PINKEL, G. MERRITT PRESTON, and GERARD J. PESMAN

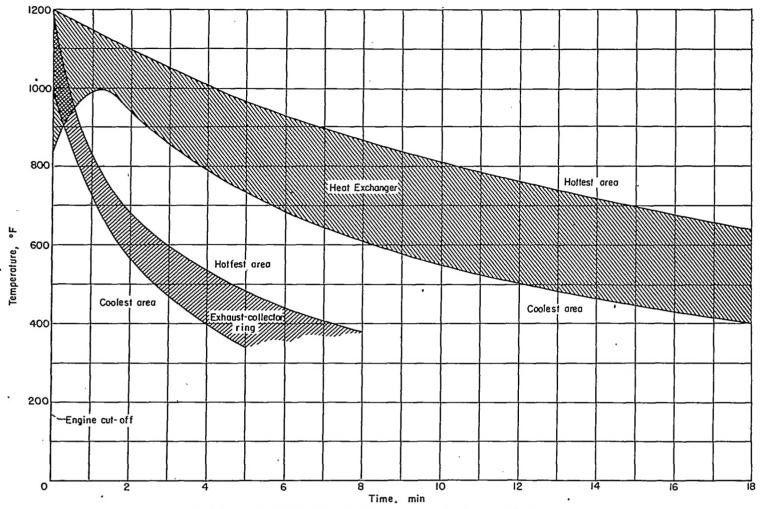
Probability of ignition on hot surfaces is high, because they are present at the moment of crash and remain at dangerous temperatures for several minutes thereafter. The temperature history of the exhaust-disposal system, for example, taken during crash (fig. 6), following operation at take-off power, indicates that it takes 30 seconds for the hottest portions of the exhaust-collector ring to cool to 950° F, the lowest temperature at which gasoline will ignite readily on the external surfaces of the exhaust system, and 84 seconds to cool to 760° F, the lowest temperature at which lubricating oil was observed to ignite readily.

FIGURE 6.—Temperature-time history of exhaust system during crash test.

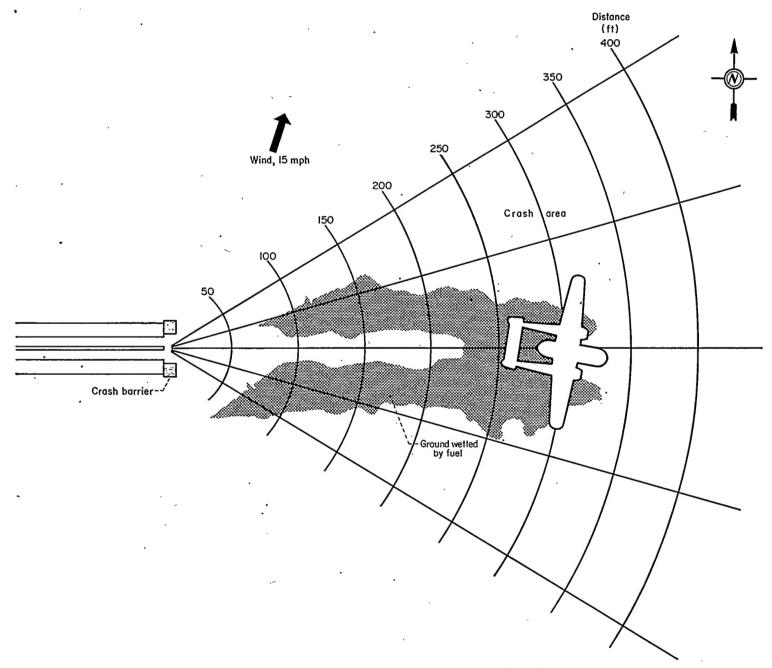
FIGURE 10.—Characteristic ground-wetting pattern of fuel deposited in wake of airplane.

A characteristic ground-wetting pattern provided by the fuel deposited in the wake of the airplane is shown in figure 10. The fuel trail deposited at the barrier is composed of two separate bands, one for each wing, which tend to broaden and finally coalesce in the neighborhood of the airplane rest point. When a tailwind blows, the ground-wetting pattern extends forward of the wing leading edge. In general, the inertia of the fuel carries it forward of the airplane rest point.

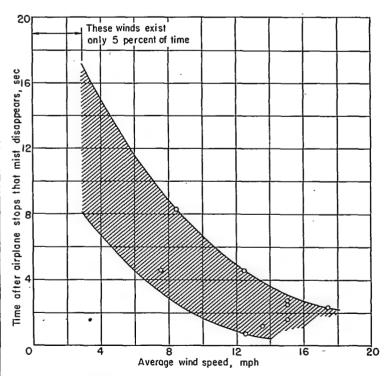
Time duration of mist ignition hazard.—Fuel mists in ignitible concentrations seldom persist around the airplane for more than 17 seconds after the airplane comes to rest. The larger mist droplets rain to the ground, and the air-borne fuel droplets are swept from the area by the wind. In passing from the area of the crash, the fuel mist may be blown over the engine nacelles, and, during the first few seconds of this period, the probability of mist ignition is significant. The hazardous period is short, because the last portion of the fuel mist to pass over the airplane is diluted below the ignitible limit. Even on calm days, the air dragged by the crashed airplane in its slide along the ground sweeps over the airplane when it comes to rest, and brings with it some of the fuel mist suspended in the airplane wake. Fuel-mist dispersal times taken from motion pictures of the crash are plotted in figure 11 as a function of the wind speed. The dispersal time decreases inversely with the wind speed in the expected manner. Because of the large error inherent in making a visual estimate of the persistence time of the fuel mist in the neighborhood of the airplane, indicated by the scatter of the data of figure 11, it was not possible to evaluate the effect of fuel volatility on this persistence time. Fuel

FIGURE 11.—Effect of wind velocity on time after airplane stops that fuel mist remains around crashed airplane.

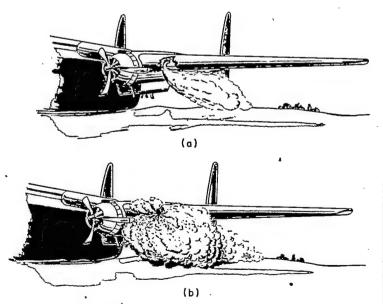
(a) High speed and low deceleration.

(b) Low speed and high deceleration.

FIGURE 14.—Schematic diagram showing effect of deceleration and airplane speed on spanwise propagation of fuel mist emerging from ruptured fuel tank.

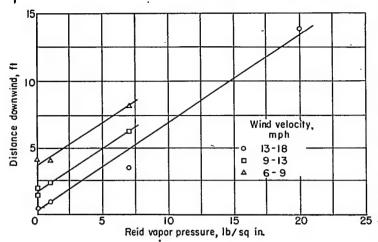
FIGURE 22.—Maximum distance downwind from nozzle rig that flame will propagate upwind as a function of fuel volatility and wind velocity. Ambient-air temperature, 68° F.

an air temperature of 68° F, with a fuel-flow rate of 178 gallons per hour through 17 hollow-cone spray nozzles each having a nominal rating of 10.5 gallons per hour. The data of figure 22 show that, in a given crash involving ignition of fuel mist, the maximum downwind distance the ignitor may be from the point of fuel spillage for the flame to propagate upwind to the airplane through the mist varies directly with fuel vapor pressure and inversely with wind speed. The maximum downwind distance from the fuel source at which upwind flame propagation will occur for gasoline mists (7 lb/sq in. Reid vapor pressure) decreases from 8 to 5 feet when the wind speed is increased from 8 to 18 miles per hour. At a wind speed of approximately 16 miles per hour, a change from gasoline to isopentane (20 lb/sq in. Reid vapor pressure) raises this maximum flame propagation distance from 5 to 14 feet. Because the distances given on figure 22 are a function of the rate of flow of the fuel generating the mist, magnitudes shown are of limited significance. The relative magnitudes given are important, however. These data are consistent with those obtained by the Texas Company in a comparable study (ref. 13), in which the fuel mists were generated by dropping fuel-filled bottles on a concrete platform exposed to a known wind. The presence of the crashed airplane and its debris can modify these results materially by providing wind-protected zones having lower wind speeds than those prevailing generally. The likelihood of upwind flame propagation through the fuel mist along these wind-protected zones is increased over that which would exist in an unobstructed wind.

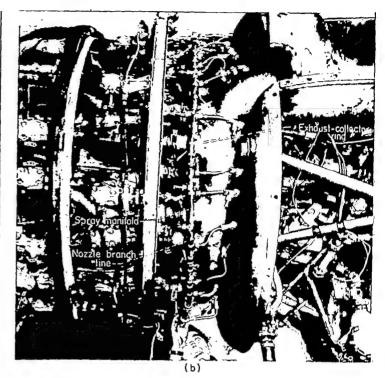
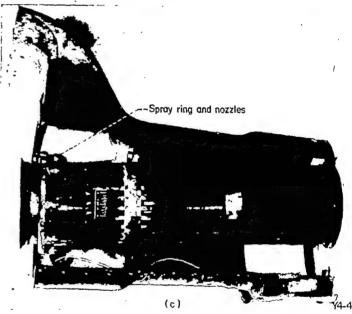
(a) Schematic diagram of nacelle installation.

FIGURE 32.-Water-spray system of ignition-source inerting system.

(b) Water-spray system for exhaust-collector ring.(c) Water sprays for exhaust heat exchanger.

FIGURE 32.—Concluded. Water-spray system of ignition-source iner ing system.

The fourth element of the ignition-suppression installation was a system of water sprays distributed to give a simultaneous uniform coverage of the hot metal of the exhaustdisposal system and the associated tail-pipe heat exchanger. The water spray served the twofold purpose of rapidly cooling the hot metal to safe temperatures and providing, meanwhile, a protective blanket of steam generated on the hot surfaces that inerts the adjacent atmosphere. Water was the fluid selected for this purpose because of its high heat of vaporization and low molecular weight. Relatively small weights of water provided effective cooling and generated large volumes of inerting steam in the high-temperature zones adjacent to the hot metal. A consideration of the heat capacity of the hot metal of the exhaust-disposal system and the heat exchanger and the temperature drop of 250° F required to reduce the metal temperature from the maximum temperature of 1200° F at the moment of crash to the lowest exhaust-system surface temperature at which gasoline will readily ignite (950° F) yields a water requirement per nacelle of approximately 1/2 gallon for the C-82 airplane. In order to provide a safety factor, 4 to 6 gallons of water were employed for each nacelle.

The essential elements of the water-spray system are shown schematically in figure 32 (a). The water, contained under nitrogen pressure of approximately 400 pounds per square inch, was distributed to all hot metal elements of the engine exhaust system through the 34-inch-diameter manifold shown in figure 32 (b). The spray nozzles and branch lines terminating in spray nozzles are required to provide uniform water coverage of the hot metal parts. In order to provide rapid cooling of the hot metal, water was also sprayed into the interior of the exhaust system at six equally spaced locations, one of which is visible in figure 32 (b) at the junction-of the tail pipe with the collector ring. The equivalent water-spray installations for the exhaust-gas heat exchanger are shown in figure 32 (c). The necessity for providing a protective blanket of steam around the external surfaces of the hot metal, where contact with combustibles may occur, while it cools to safe temperatures, fixes the external appli-

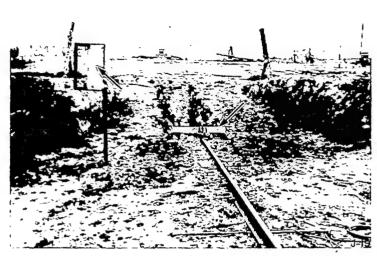
In the crash, the inerting system was actuated by a switch carried on the guide-rail slipper fastened to the nose-wheel strut, a photograph of which is shown in figure 36. A plywood target (fig. 37) was placed across the rail at the crash barrier to operate the switch after the propellers struck the barrier abutments. To provide a margin of safety against switch failure, a second switch connected in parallel was carried on the side of the airplane. The second plywood target shown on the angle iron support in figure 37 served this auxiliary switch.

FIGURE 37.—Inerting-system-switch target.

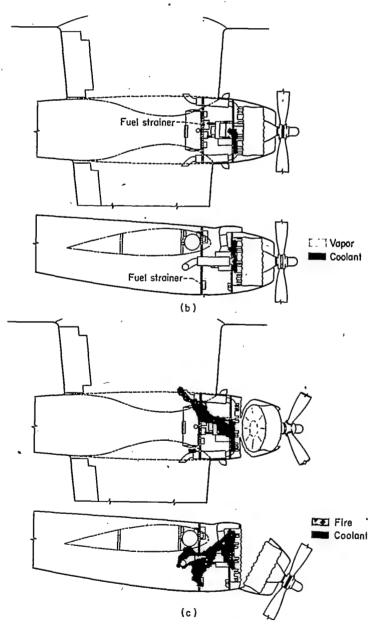
- (b) Schematic diagram of nacelle showing location of combustible vapor and coolant in nacelle 0.75 second after initial impact.
- (e) Schematic diagram of nacelle showing fire indicated by detectors in nacelle 4.2 seconds after initial impact.

FIGURE 38.—Mechanism of ignition by hot metal of exhaust-collector ring.

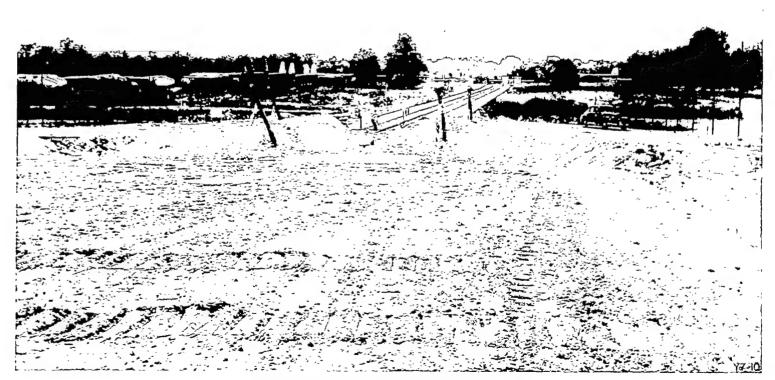
FIGURE 42.—Crash area for high-contact-angle crash.

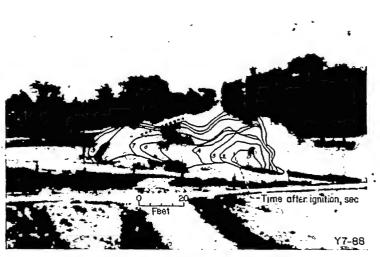
both wings (fig. 44 (d)). The flame-propagation rate through the fuel mist around the airplane was determined as 75 feet per second with a 30-foot-per-second tail wind, or a net speed of 45 feet per second (fig. 45). This high rate of flame propagation includes the velocity imposed on the flame front by the expanding burning mass of fuel and air. The large column of fuel mist suspended in the air is evident from the volume of fire shown in figure 44 (d).

FIGURE 45.—Contour of fire propagation through fuel mist after ignition in high-contact-angle crash.

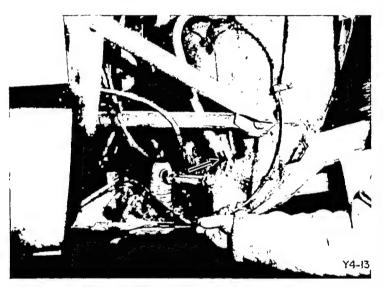
FIGURE 48.—Fuel line cut by flying propeller tip.

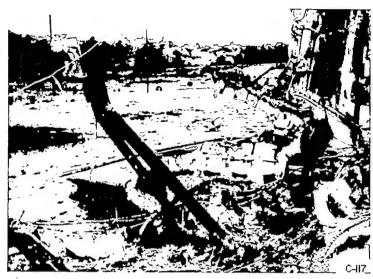
FIGURE 63.—Structural elements melted in a typical crash fire.

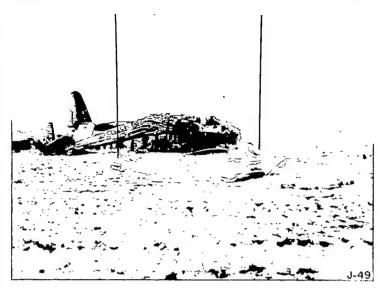
FIGURE 64.—Structural collapse due to melting and burning of skin and structural memliers.

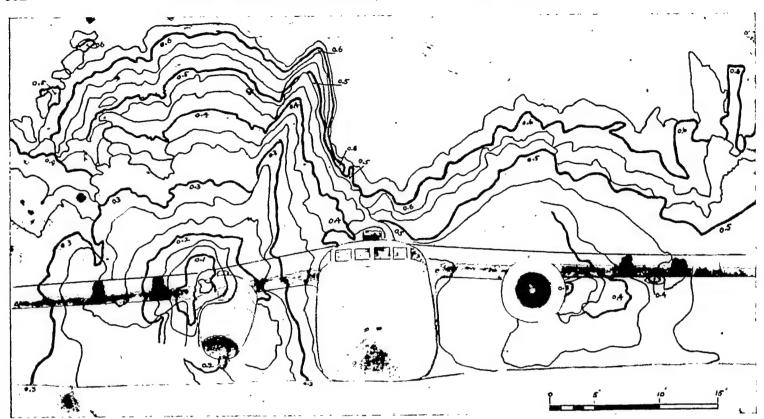
left side of the airplane. A map of the progress of this fire during the first second following ignition as the flame propagates from the right nacelle towards the left side of the airplane is shown in figure 65. The family of curves in the figure represent the outline of the fire in 0.1-second intervals, starting at the right nacelle and later at the left engine tail pipe. These data show an average vertical rate of propagation of the fire of 60 feet per second and a uniform horizontal rate of 25 feet per second over a 0.6-second period. Explosion of both wings occurred just as this flame pattern was established and produced the fire shown in figure 61.

Figure 65.—Map of progress of fire following ignition as it appears to camera viewing airplane head-on. (Numbers refer to time after ignition in seconds.)
